BROWN'S LAKE DAM

NDI ID NO. PA-516

PHASE I INSPECTION REPORT
NATIONAL DAM INSPECTION PROGRAM

MARCH, 1981

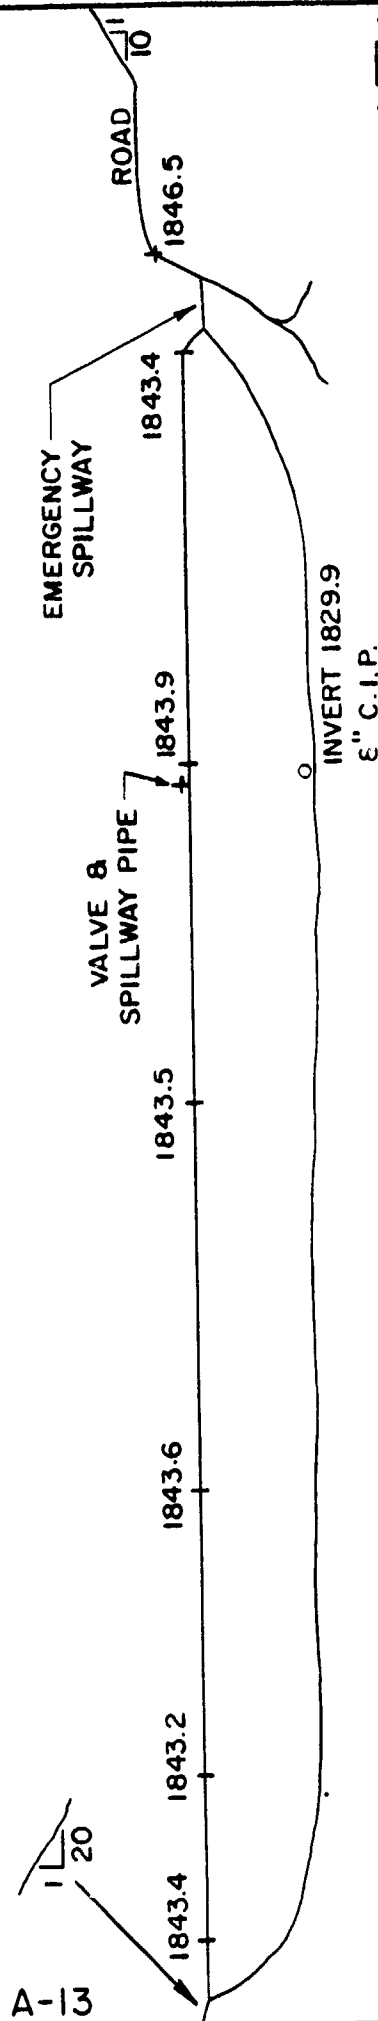
PROFILE
LOOKING UPSTREAM
HORIZ. 1"=100'
SCALE: VERT. 1"=20'

b. Dam. The dam appears to be in good condition and well maintained. From a brief survey conducted during the inspection, it was noted that a low spot exists on the embankment crest approximately 100 feet from the right abutment. The survey indicated that the low spot on the embankment crest was a localized condition.
